FACILITY COMPLIANCE INSPECTION REPORT

Division of Waste Management Solid Waste Section

Date of Site Inspection: January 17, 2013 **Date of Last Inspection:** January 31, 2012

M^cGill Environmental Systems of NC, Inc. – Merry Oaks Facility Large, Type 4 SWC Facility
 634 Christian Chapel Church Road
 New Hill, NC 27562

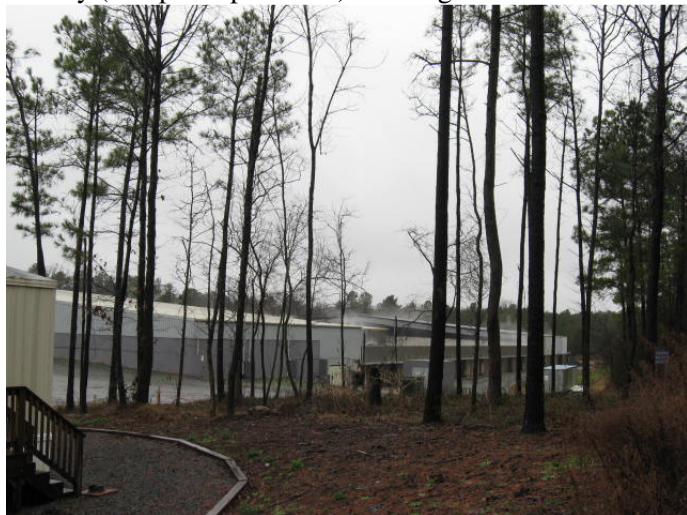
Facility (compost operations) building

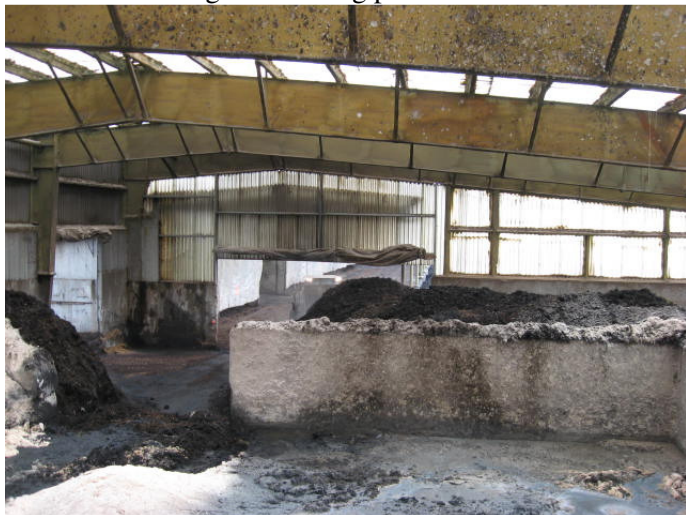
9. Active compost operations and compost curing are conducted within the facility building. Feed stocks are off-loaded into a mixing and bulking pit. Bulking material is brought into the pit from outside via adjacent bay door. Mixed material is stockpiled within the pit area until enough is on-hand to create an active compost pile. The material is placed into positive aeration active compost bays to meet “process for further reducing pathogens” (PFRP). Afterwards, material is screened (via dedicated screener) and placed in a triple-wide bay to meet “vector attraction reduction” (VAR). Material removed from the active compost bays awaiting VAR is stockpiled in the building, in an area open to the weather/not under cover. This area is ~ 15,000 yd³. The pile of screened material, to be placed in the VAR area, is stored outside until moved into the building. Overs from this screening process are stockpiled in the building open weather storage area. Material is considered cured after achieving VAR. Cured product is screened (via dedicated screener) and stored outside. The rescreened compost is finished product. Finished product is stored in storage bays constructed of large cement block.

Materials mixing and bulking pit

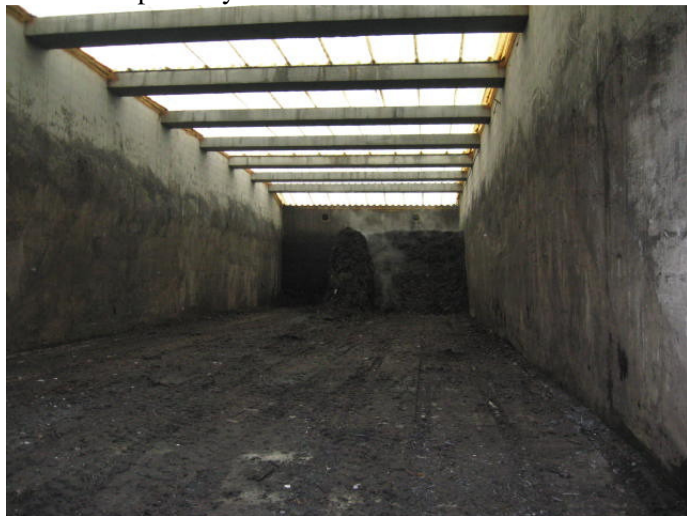
11. An active compost bay pile is constructed with a layer of wood chip, 7 feet of material to be composted, and 1 foot of finished compost along the front of the pile, facing the open end of the bay.

Active compost bay

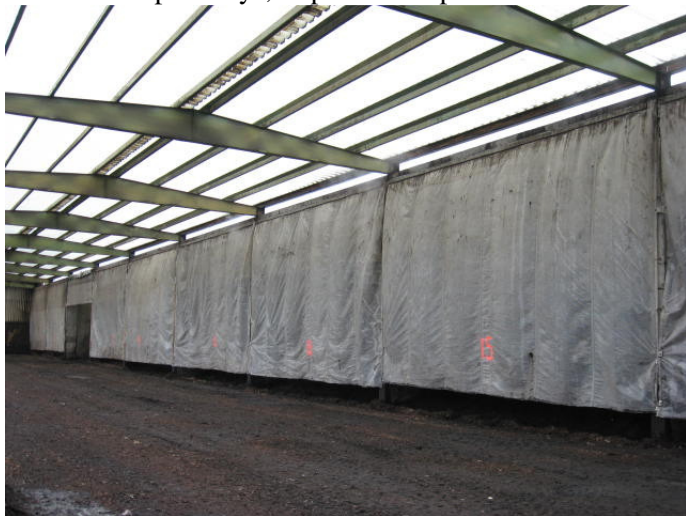
13. Each active compost bay has a reinforced polyethylene laminate material tarp that remains in-place across the open portion of the bay. The mixing and bulking pit bay door and entranceway within the building to the vehicle operations passageway, from the pit to the active compost bays, have the same tarps that are raised-up during daily facility operation and drawn-down afterhours.

Active compost bays, tarps across open end

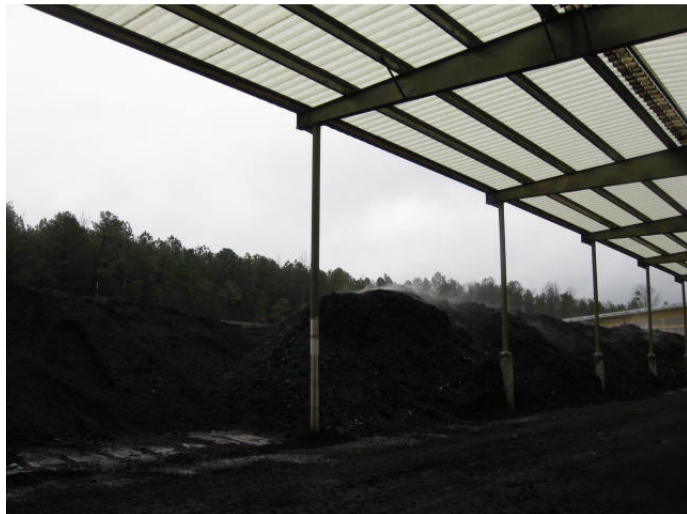
20. The facility building is ~ 112,500 ft². Rainwater that enters the building via the open to the weather/not under cover storage area is absorbed by the stockpile of material awaiting VAR. The vehicle operations passageway is covered with a layer of mulch/compost to absorb leachate. The mulch/compost is then removed and incorporated into the mixing and bulking pit.

Stored material (in building open roof area/not under cover) having met PFRP, requiring VAR

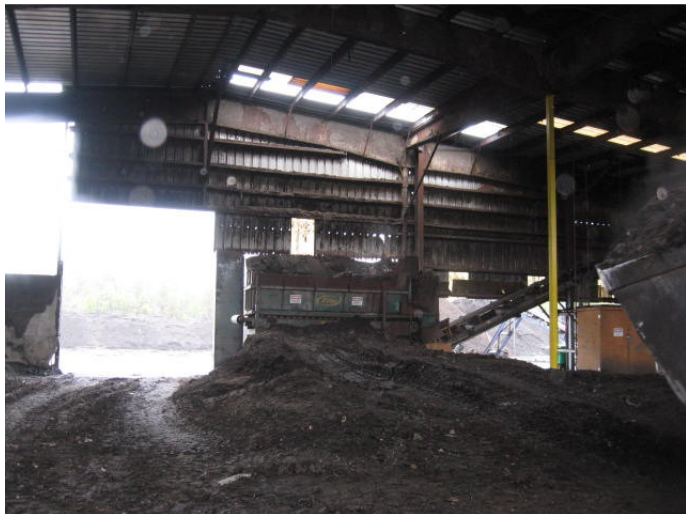
Material requiring VAR screener hopper, material conveyed outside of building

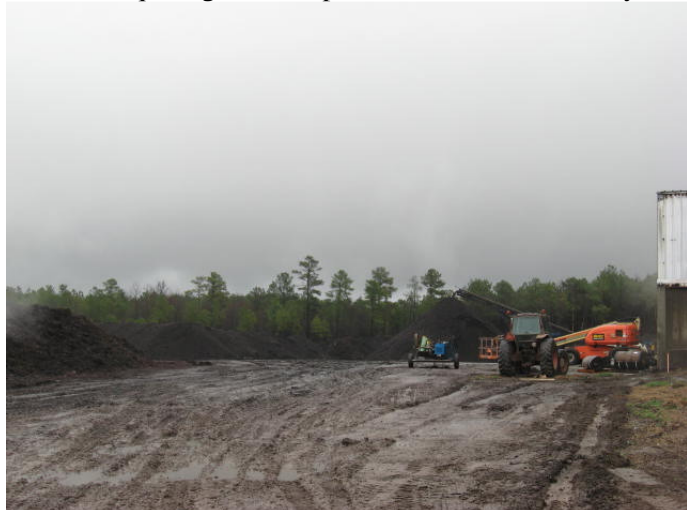
Material requiring VAR in pile under screener conveyor

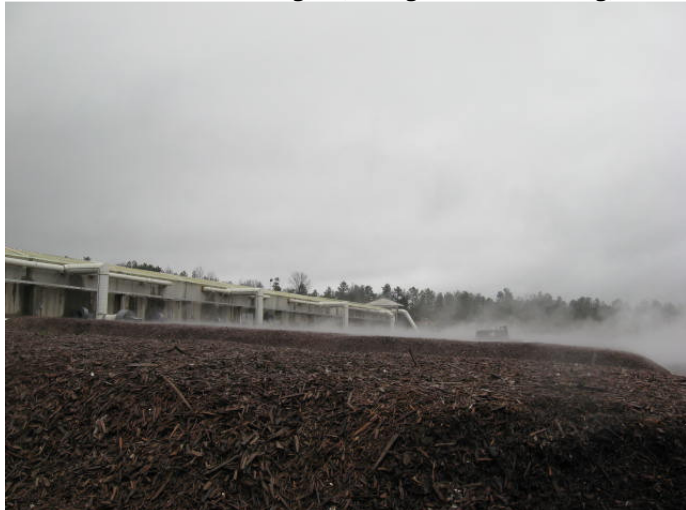
15. There are six biofilters, each containing five twelve-inch perforated plastic pipes. The biofilters are constructed on the ground, atop a clay ash pad followed by an initial layer of wood chip, perforated pipe, a layer of compost, and a second layer of wood chip. The area allotted for the biofilter is ~ 380' x 110' x 3'. Maintenance pathways/areas not covered with media are throughout the length and width of the biofilter, such that media coverage is ~ 280' - 300' in length.

16. Mr. Cockman stated that the biofilter media was replaced in May – June 2012 and should function as designed for 3 – 5 years.
17. Each group of active compost bays Nos.: 1, 3 and 5, Nos.: 7 and 9, Nos.: 11 and 13, and Nos.: 15, 17, and 19 exhausts through a manifold to one of four biofilter units. The mixing and bulking pit exhausts to a dedicated biofilter unit. And the curing area exhausts through a manifold to a dedicated biofilter unit.

Biofilter, view left to right (facing rear of building)
